Manhole Inspection Summary

Manhole # S25WW1004MH

Insp Date: **5/10/07 9:30 AM**

Location Address: **5201 ROLAND AVE**

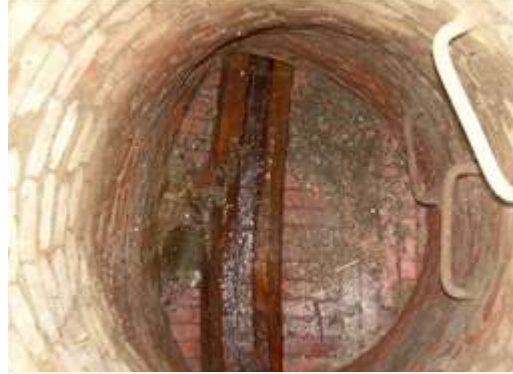
Top View

Corroded steps. Bench debris.

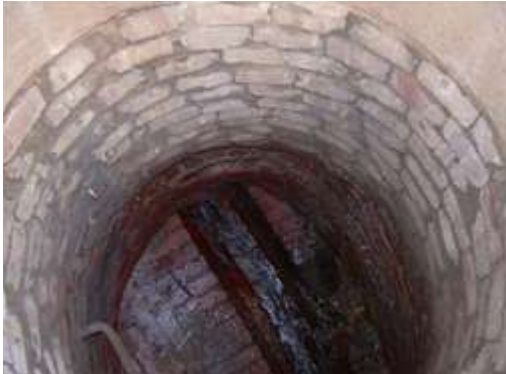
Defect

Frame leaks. Adjustment deterioration and infiltration. Corbel and Barrel infiltration.

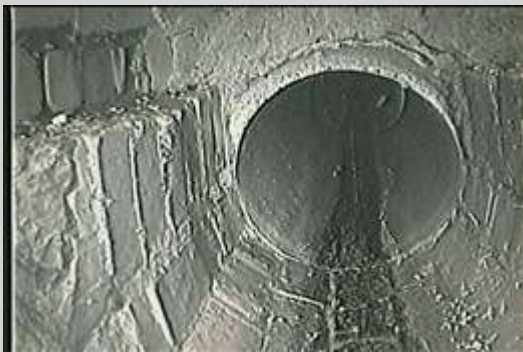
10 in. Circular Gravity Sewer Pipe Out @ 12 O'Clock

Infiltration: **Evidence** Pipe Seal Cond: **Cracked**

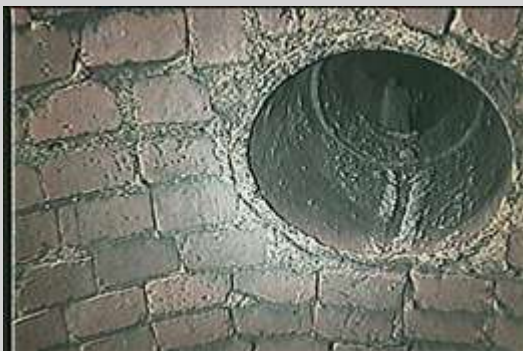
10 in. Circular Gravity Sewer Pipe In @ 6 O'Clock

Infiltration: **Evidence** Pipe Seal Cond: **Broken**

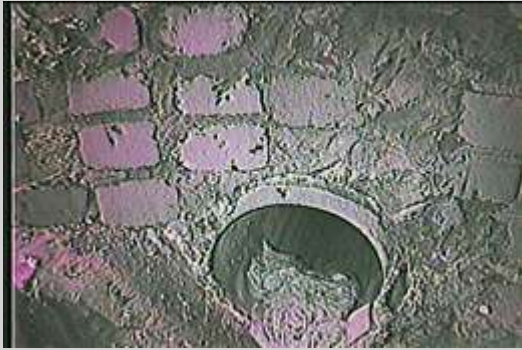
8 in. Circular Gravity Sewer

Barrel deterioration and infiltration.

Deposits: ☐ None ☐ Mud ☐ Sludge ☒ **Debris** ☐ Grease

Deposits Extent: **Light**

Infiltration: **Evidence**

Pipe Seal Cond: **Cracked**
